## CUSTOMER INFORMATION

### COMPLAINTS ON EVO ENGINE SERIES

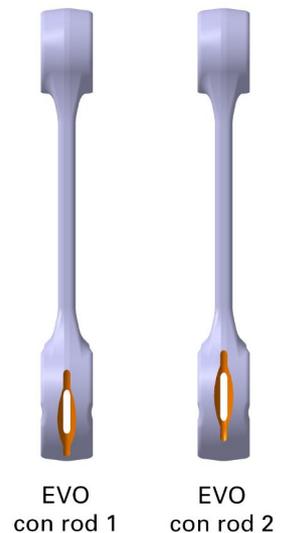
With the beginning of the racing season we have received complaints of failed evo 1 con rods.

These con rod failures have been analyzed and out of this the design of the evo 1 con rod has been slightly modified (= evo 2 con rod). This modification has significantly improved the durability of the con rod regarding the failures occurred on the market with evo 1 con rods.

As of following engine serial numbers the new evo 2 con rod is fitted as original equipment.

Customers owning a Rotax engine with an evo 1 con rod fitted will be offered, an evo 2 con rod kit free of charge if they would like to renew the con rod kit at the annual engine overhaul.

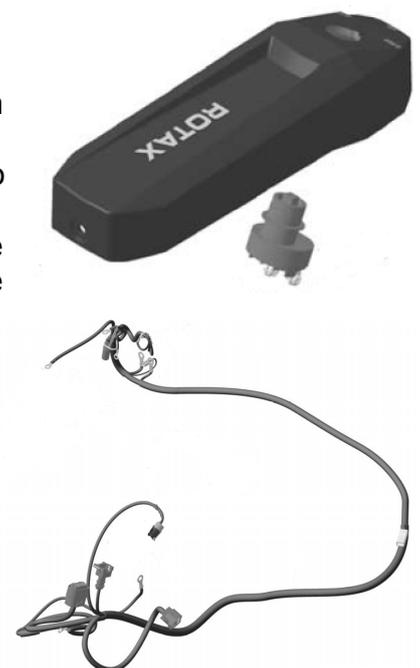
The claimed cable harnesses showed either broken connectors (ground wire, starter relay) or internal contact failures in connectors.

The vibration of the electrical components (ECU, ignition coil, magnet valve), caused by engine and vehicle vibrations, can have a negative impact on the durability of

the cable harness (depending on the installation of the cable harness in the kart).  
The cable harness has been modified in the critical areas to ensure durability and faultless function.

A failure of the cable harness is covered under the regular Rotax manufacturer's warranty.  
A failed cable harness will be replaced by a cable harness with improved design (as of January 2015).

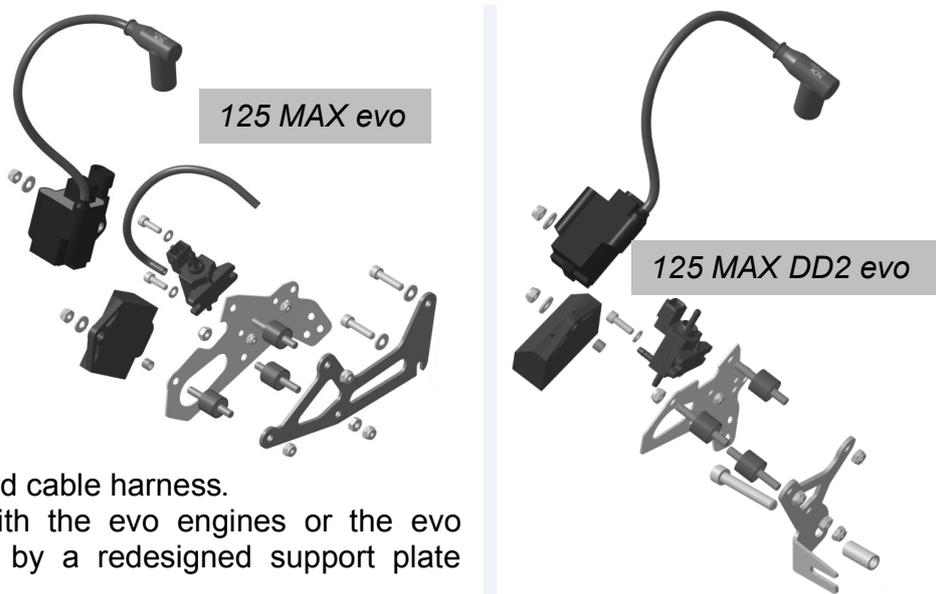
A lower vibration level of the electrical components (ECU, ignition coil, magnet valve) has a significant impact on the durability of the cable harness.

To minimize the vibration level of the electrical components BRP-Rotax will initiate an exchange campaign for the support plate which carries the ECU, ignition coil and magnet valve in combination with the improved cable harness.

The support plate supplied with the evo engines or the evo upgrade kits will be replaced by a redesigned support plate system (see illustrations).
